Developing Defect Embedded Masonry H-BIM Using Deep Learning-Based Detection and Segmentation

Abstract

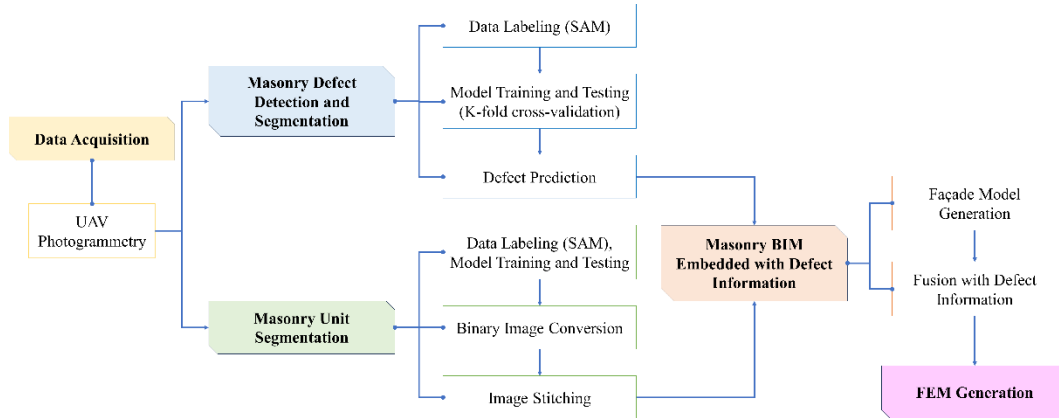
Figure 1: Proposed methodology

To achieve the objective, the following methodology has been proposed, as shown in Figure 1. The procedure of the methodology includes data acquisition, masonry defect detection and segmentation, masonry unit segmentation, and integration of defect information with masonry H-BIM.

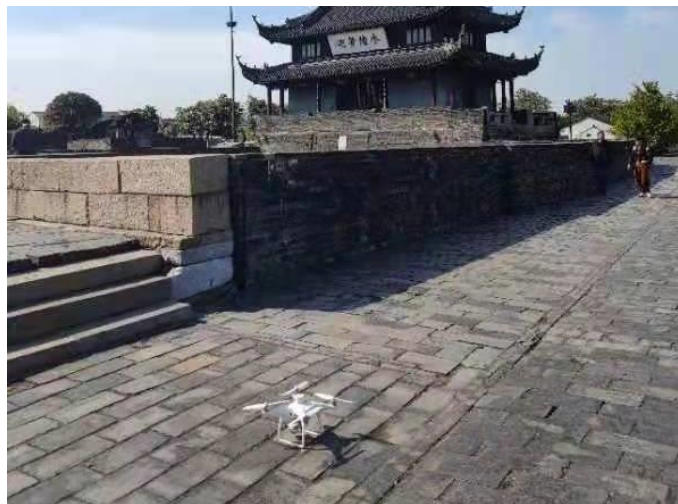
Figure 4: UAV photogrammetry at the ancient walls

The ancient walls were captured through UAV photogrammetry, as shown in Figure 4. The obtained images were used for YOLO model training and defect prediction. To prepare the YOLO dataset, images of three sides of the walls were used for model training and testing, while the last part of the wall was used for defect prediction and generating the H-BIM model of the masonry structure. During image acquisition, the camera needs to be kept as parallel to the wall as possible. For the images used for prediction, each image was removed distortion, and then all images were stitched to form a complete picture of the entire ancient wall surface. In the stitched complete picture, parts that do not belong to the wall, such as the ground and sky, were removed, as shown in Figure 5. This step was taken to facilitate the set of the wall coordinate system and match it with the point cloud coordinate system.

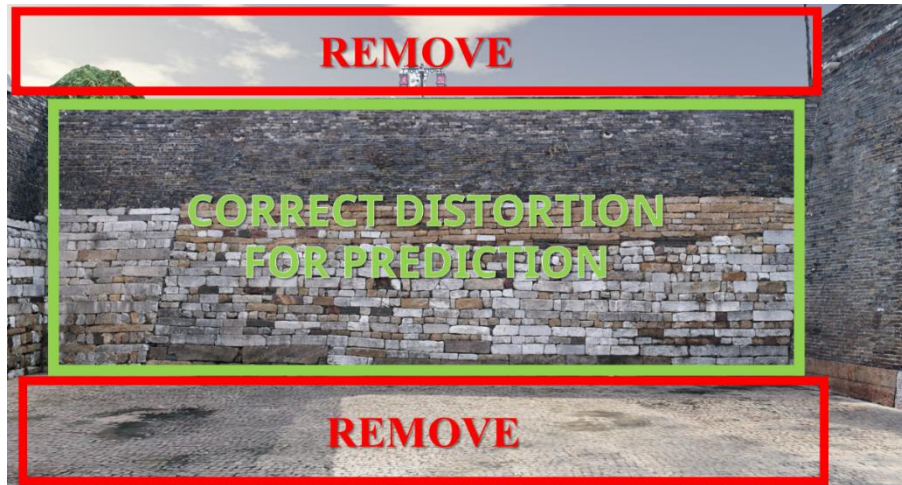
Figure 5: Regions to be removed and to be corrected distortion in the stitched picture.

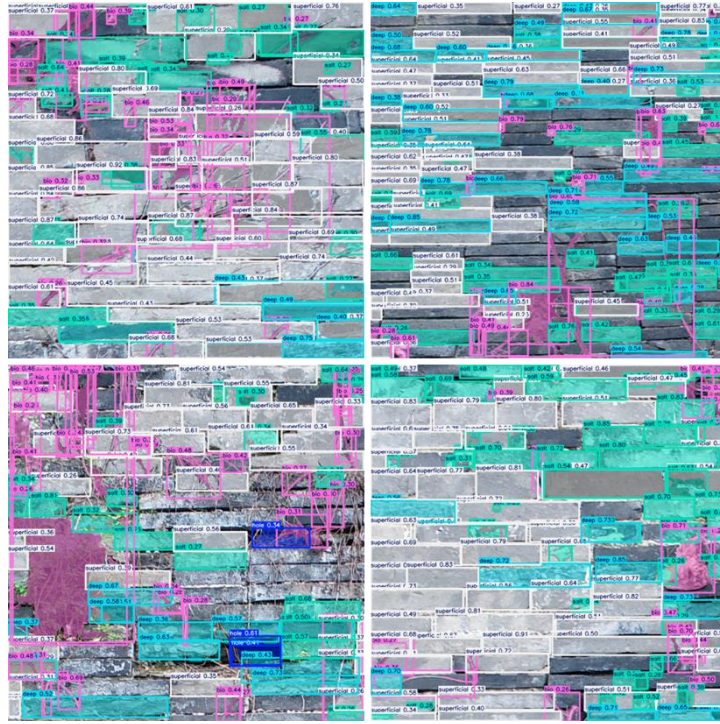
Figure 6: Defect detection and segmentation results

500 uniformly cropped images were used for training. Five defect categories were defined for mask labeling, including *Deep erosion*, *Superficial erosion*, *Efflorescence*, *Missing part*, and *Biological colonization*. In the data training process, YOLOv11m-seg was selected as the pre-trained model, which offered moderate performance with acceptable accuracy without wasting resources. The dataset was divided into five subsets for K-fold cross-validation to mitigate the impact of sample category imbalance. The obtained training weight file best.pt was used for defect detection and segmentation on the other part of the ancient wall. Some prediction results are shown in Figure 6. In the images, red masks with the label "bio" stands for "*Biological colonization*", light blue masks with label the "deep" stands for "*Deep erosion*", white masks with the label "superficial" stands for "*Superficial erosion*", green masks with the label "salt" stands for "*Efflorescence*", and dark blue masks with the label "hole" stands for "*Missing part*". It can be observed that the trained model accurately detected and segmented the majority of defects. There were a few inaccurate detections that need further improvement. For example, some small plant leaves were not detected, some large areas of biological colonization or efflorescence could not be completely segmented, some bricks without defects were misidentified as erosion, and there were cases of repeated boxing in some locations.
